PHOTOGRAPHIC INTERPRETATION REPORT

SOVIET MILITARY ORDER OF BATTLE BALTIC MD

VILNYUS MILITARY BARRACKS VILIYA RIVER

VILNYUS, LITOVSKAYA SSR, USSR

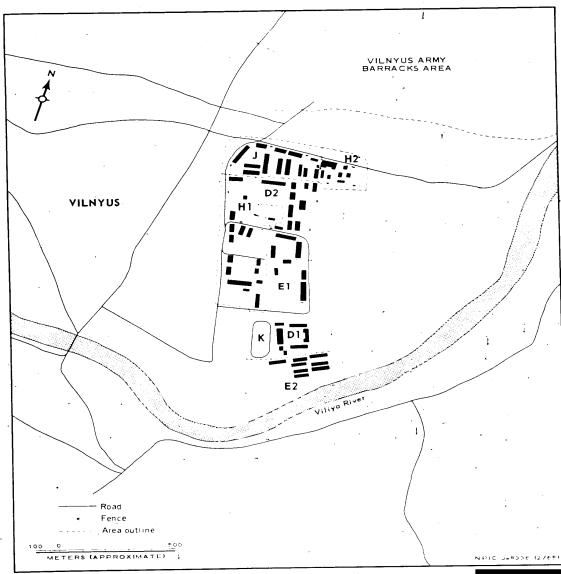
FIGURE 3. VILNYUS MILITARY BARRACKS VILIYA RIVER. Sketch compiled from Mission

Area DI contains 4 multistory barracks, 1 multistory administration building/barracks, 4 and 2 support buildings.

Area D2 contains 9 multistory barracks, 8 single-story barracks, 8 support buildings, 1 administration building, one 150- by 40-foot-vehicle maintenance shed, and possible open storage.

Area El contains 5 storage buildings and open storage.

Area E2 contains 8 storage buildings.

Area $\overline{H}1$ contains 1 possibly bunkered building.

Area H2 contains 6 unidentified buildings and 1 multistory possible administration building.

Area J contains 14 vehicle maintenance and storage buildings; two 250 by 65 feet, one 350 by 65 feet, two 280 by 65 feet, one 210 by 45 feet, one 150 by 65 feet, one 150 by 50 feet, one 30 by 45 feet, one 120 by 40 feet, one 220 by 40 feet, one 190 by 40 feet, one 135 by 45 feet, and one 370 by 60 feet.

Area K is an oval track and parade ground.
